# JURISDICTIONAL WATERS DETERMINATION FOR THE ROSEMONT COPPER PROJECT UTILITY CORRIDOR AND WEST SIDE OPERATIONS, PIMA COUNTY, ARIZONA

**Prepared by:** WestLand Resources, Inc., *on behalf of* Rosemont Copper Company

**Date:** September 20, 2019

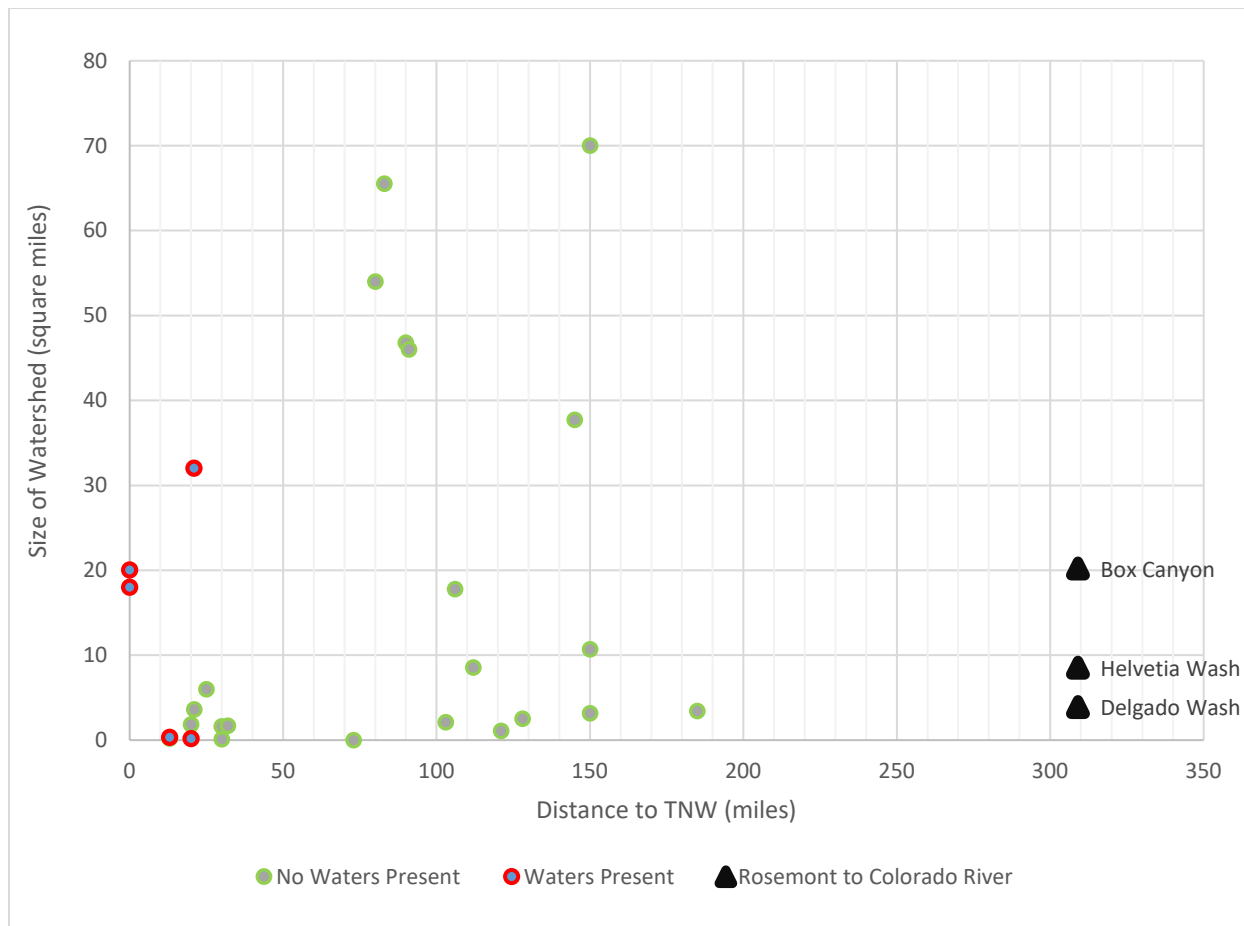
**Exhibit I.** Watershed size and distance of largest Non-RPW in previously approved SNA JDs with the three largest Analysis Area relevant reach watersheds plotted against the Colorado River.

compared to the Colorado River. All three relevant reaches clearly plot well outside that portion of the graph in which the Corps has typically asserted jurisdiction.

In addition to the specific Approved JDs described above, WestLand reviewed publicly available information on more than 20 additional Approved JDs (with SNA) in Arizona. **Exhibit 1** provides a graph of these previous Approved JDs, plotted based on the distance and relative watershed size between the largest non-RPW in each JD and the nearest designated TNW. Included in the exhibit is a plot of the three largest watersheds associated with relevant reaches in the Analysis Area (Box Canyon [20.2 square miles (sq mi)], Helvetia Wash [8.52 sq mi], and Delgado Wash [3.88 sq mi])

It is important to note that in the two JDs in which WOTUS were determined present, and the largest surface water features are plotted less than 20 miles to a TNW and have a very small watersheds, the intervening surface water features (Pinto Creek and Pinal Creek) are intermittent to perennial in nature.

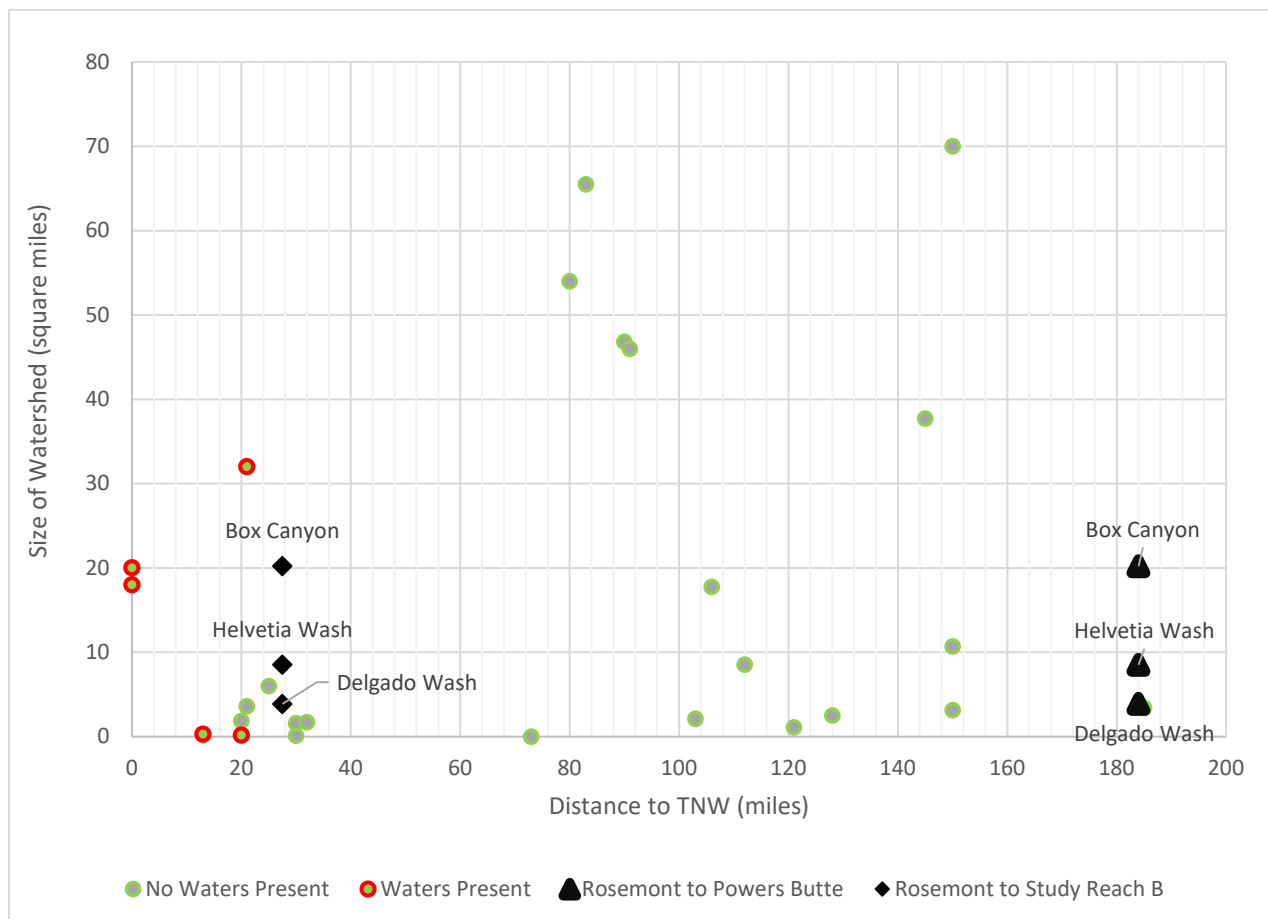
Even when comparing the three Analysis Area relevant reaches to Study Reach B of the Santa Cruz River or the Gila River at Powers Butte, these features still plot within the non-jurisdictional area of the graph (**Exhibit 2**).

**Exhibit 2.** Watershed size and distance of largest Non-RPW in previously approved SNA JDs with the three largest Analysis Area relevant reach watersheds plotted against Study Reach B of Santa Cruz River and the Gila River at Powers Butte. The two WOTUS determinations plotted near the watershed size (Y-axis) 0 line had intermittent to perennial reaches covering a substantial distance between the Analysis Areas and the nearest TNW.
